# Woodridge Library

1801 Rhode Island Avenue. NE, Washington, DC

## **Facility Condition Assessment & Cost Benefit Analysis**

January 10, 2011

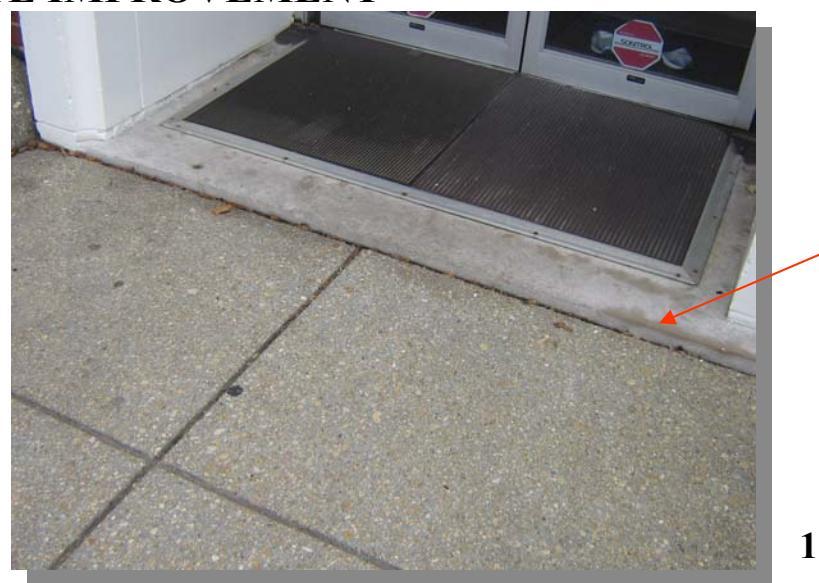
A. SIDEWALKS, CURBS AND ENTRY PATIO										
1. Existing front entry sidewalk and concrete paving	2,000	sf	\$5	\$ 10,000	\$ 3,000	70%	Fair	3.50	1	Replace concrete parking. Replace trip hazards at front entry

Replace offset concrete at front entry to avoid trip hazards.

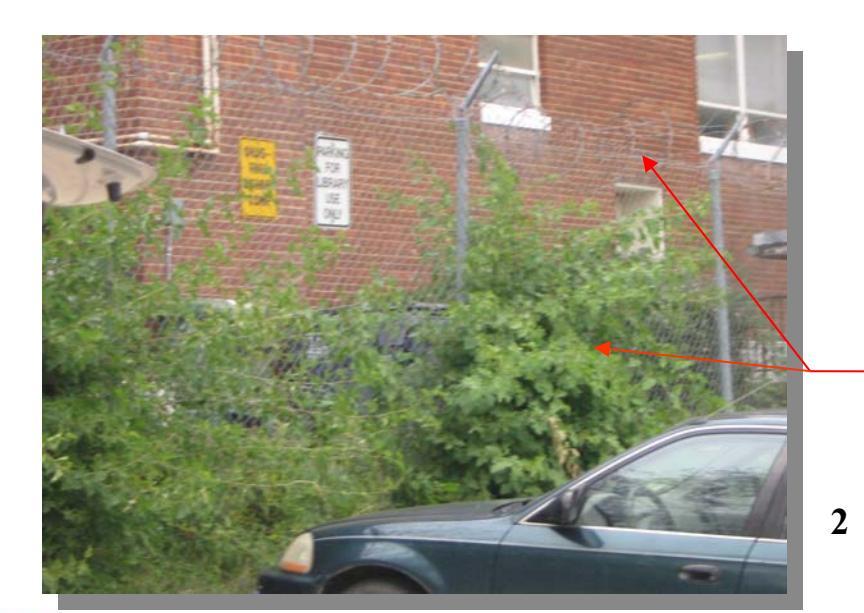
2. Landscaping	1	ea	\$8,000	\$ 8,000	\$ 4,000	50%	Poor	2.50	2	Prune existing planting and provide additional planting to augment existing landscaping.
B. PARKING AREA	-		:				- C			
<ol> <li>Existing deteriorated concrete parking lot.</li> </ol>	3,000	sf	\$8	\$ 24,000	\$ 24,000	0%	Failed	0.00	3	Replace entire deteriorated conrete parking lot

Landscaping is in fair condition, however overgrowth requires pruning. Additional planting will enhance overall appearance

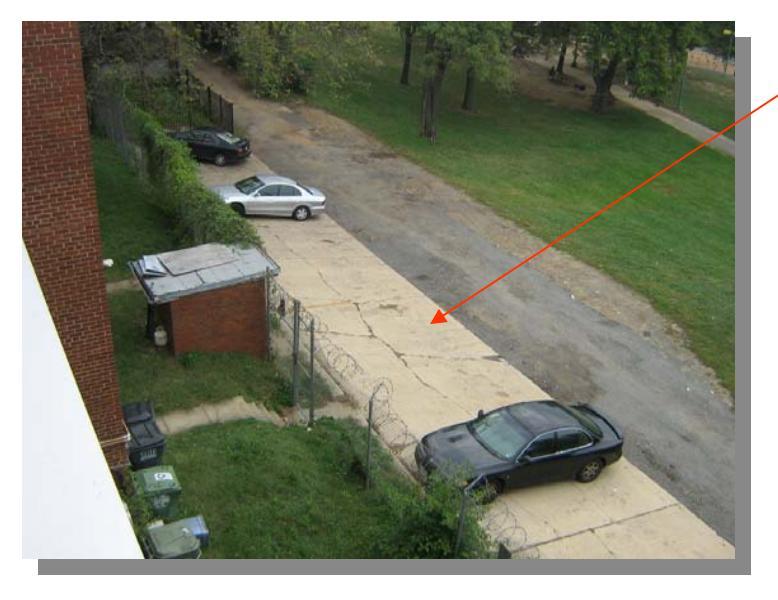
2. Existing asphalt drive aisle.	1	ea	\$15,000	\$ 15,000	\$ 5,000	67%	Fair	3.33	3,4	Repair includes filling of cracks, cutting potholes and resealing
3. Vehicular stripping	1	ea	\$2,000	\$ 2,000	\$ 2,000	0%	Failed	0.00	3	Modification shall include revised drive aisle and new parking spaces meeting ADA requirements, along with full stripping

Rear concrete parking slab and asphalt drive aisle are in poor condition and show signs of major spalling and cracking.

Vehicular striping will appropriately distinguish HC parking from typical parking spots

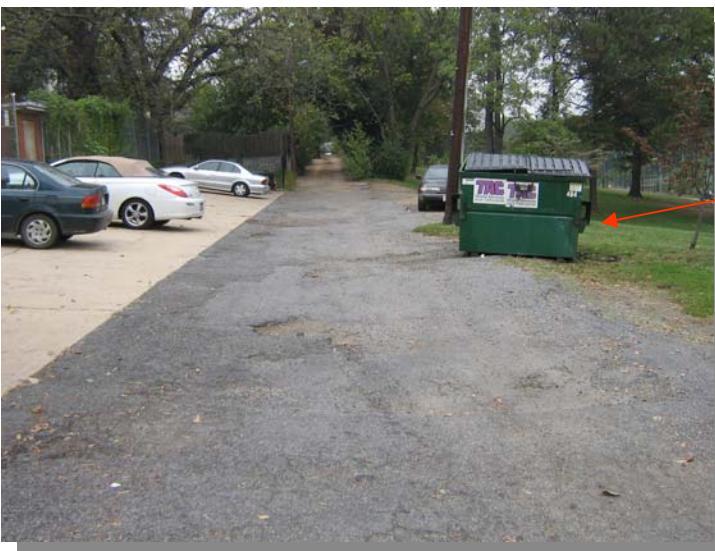
C. DUMPSTER PADS AND ENCLOSURES					 					
<ol> <li>New dumpster screen fencing, screen gates, concrete pads and bollards.</li> </ol>	1	ea	\$25,000	\$ 25,000	\$ 25,000	0%	Failed	0.00	4	The dumpster is not enclosed. Consider installing new dumpster enclosure with new pad and gates for better security and appearance.

- Existing dumpster should be enclosed for security and site appearance.

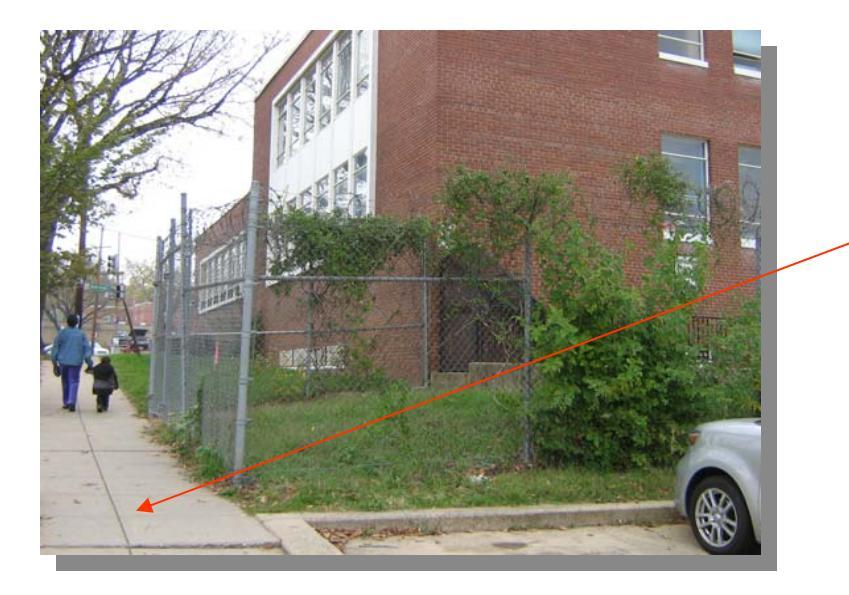
9

Handicapped accessible route from parking exceeds maximum slope. In addition, there is no designated handicapped parking.

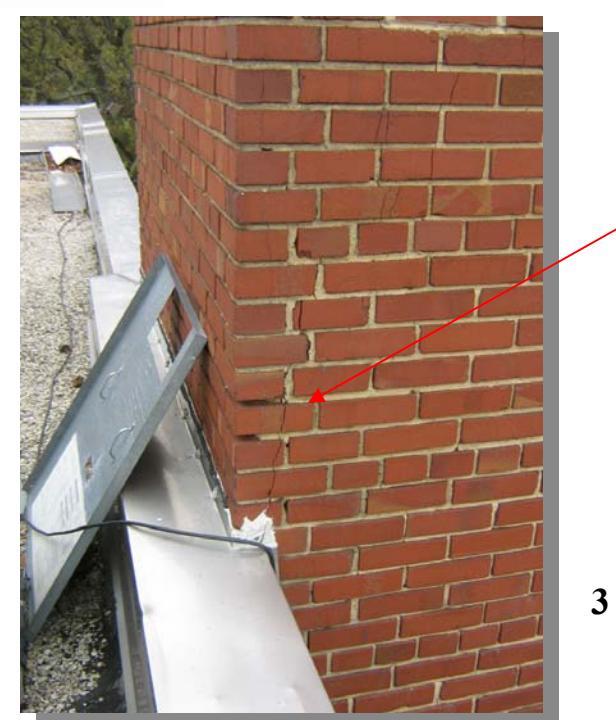
1. Masonry exterior wall	8,500	sf	\$15	\$	123,250	\$	15,000	88%	Good	30.74	3	lack of masonry control joints and differential settlement have caused cracks in bricks which may lead to water infilltration. Replace damaged bricks and repoint at miscellaneous locations

Lack of masonry control joints and differential settlement have caused bricks to crack at various places on the façade however masonry is generally in good overall condition.

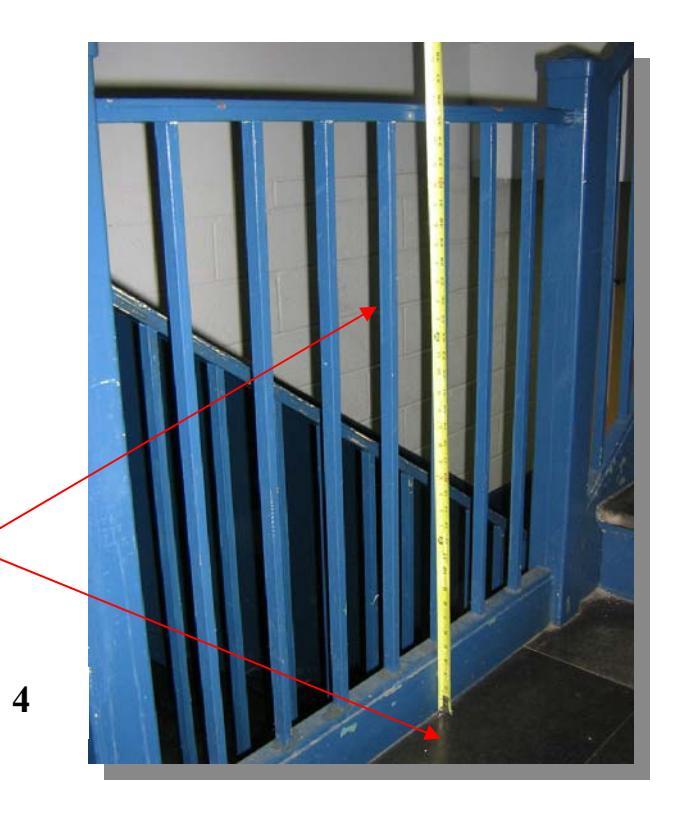
C. STAIR SYSTEM				$\vdash$								
1. Existing steel stair system	4	flights	\$7,650	\$	30,600	\$	8,000	74%	Fair	25.85	4	Replace existing stair tread and landing finishes. Minor repairs needed to damaged nosing. Bring guardrails and handrails up to code.

Current stairwell floor finish is in need of repairs or replacement. Lack of handrails on masonry walls and noncompliant guardrail height at landings must be brought up to code (guardrails must be 42" AFF).

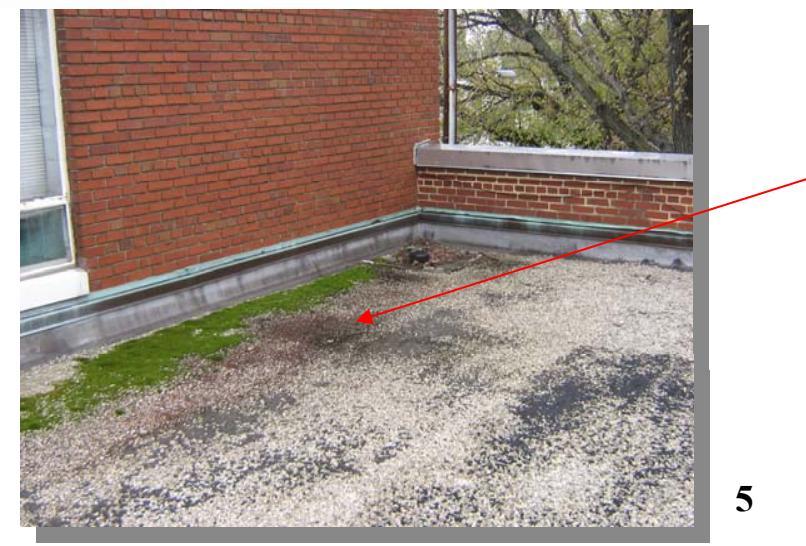
D. ROOFING												
1. Roofing and ballast.	10,266	sf	\$18	\$	184,788	\$1	84,788.00	0%	Failed	0.00	5	The existing roofing is in marginal to poor condition with minimal slope. Areas of ponding were noticied, many areas have beer patched and vegetation is growing. Cost

Lack of proper roof slope have caused ponding to occur and growth of vegetation. Areas of roof leaks were indicated by maintenance staff.

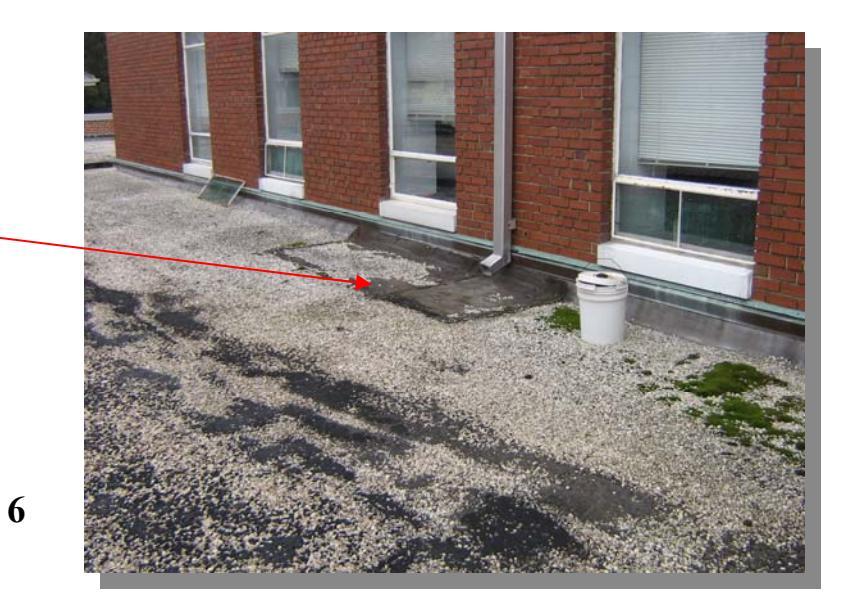
2. Miscellaneous roof accessories	1	ls	\$3,500	\$	3,500	\$	3,500	0%	Failed	0.00	6	Replace access door to roof, roof ladder and coping which is pulling away from parapet

Existing roof patches demonstrate that the roof has outlived its intended lifespan. Metal flashing appeared in fair condition, however some areas were deteriorating or pulling away from walls and parapet.

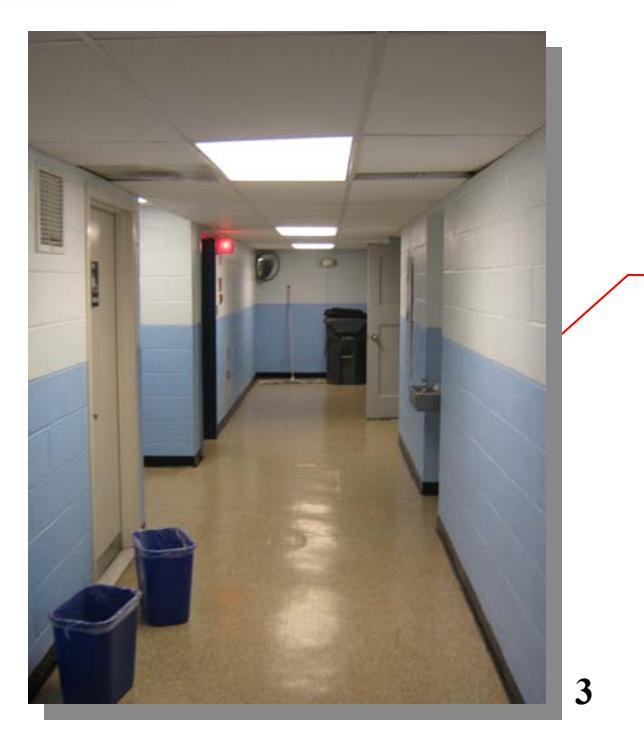
B. OFFICES, MEETING ROOM, SUPPORT AREAS AND STAIRWELLS												
1. Finishes a. Carpet/Vinyl Composite Floor Tile	9,185	sf	\$2	\$	18,370	\$	18,370	0%	Failed	0.00	3	Flooring in the offices, corridors, and miscellaneous support areas are original or near original and in poor condition. Complete replacement is required.

b. Suspended Acoustical Ceiling System	8,500	sf	\$5	\$	42,500	\$	42,500	0%	Failed	0.00	3	Some of the ceiling tiles have been replaced at miscellaneous locations, but the suspension system is in poor condition. The entire suspended ceiling system will need to be replaced.

Floor and ceiling finishes, furniture and fixtures are dated and worn in meeting rooms and corridors in basement and second floor.

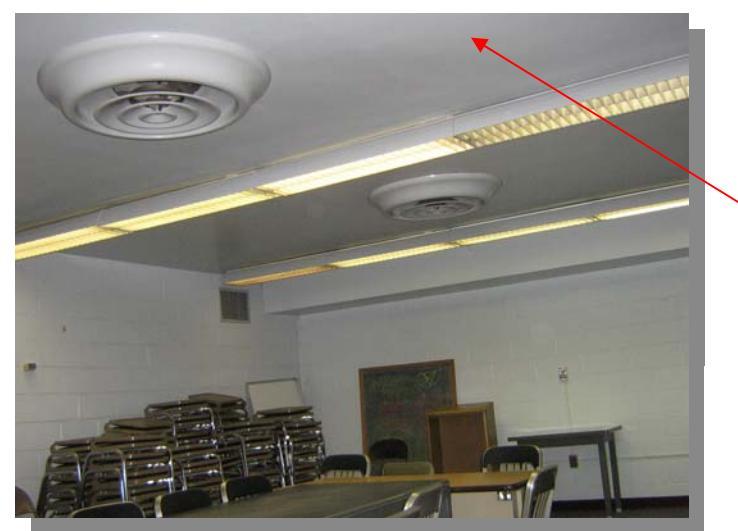
c. Plaster/hardboard ceiling and walls	300	sf	\$35	\$	10,500	\$	2,000	81%	Good	8.10	5	Plaster ceiling and wall finish are in overall good condition however some minor repair is needed in miscellaneous office/meeting room areas as a result of water damage.

Hardboard ceilings appear to be in fair/good condition. Minor spot repair are needed in some basement areas.

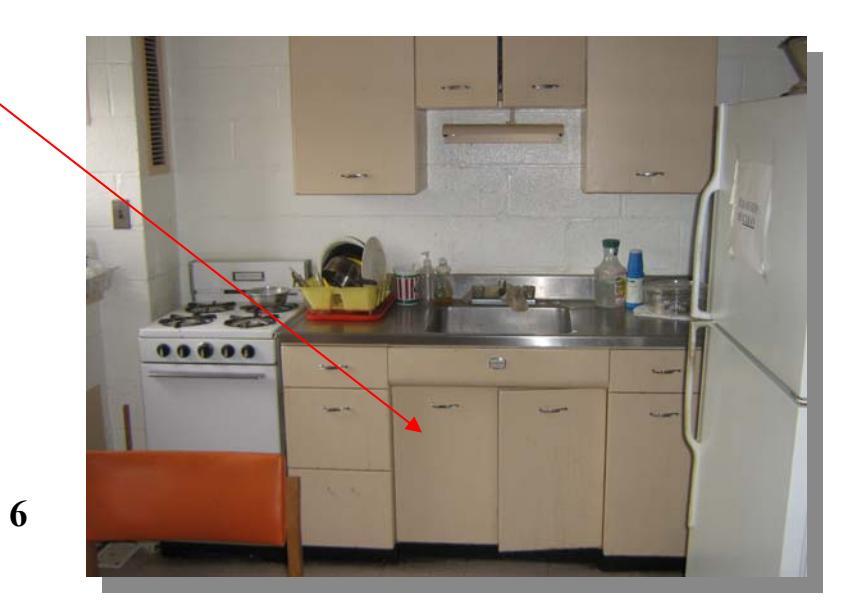
a. Cabinetry a. Cabinetry at staff kitchen	1	ls	\$8,000	\$	8,000	\$	8,000	0%	Failed	0.00	6	Original cabinets in lounge need to be replaced. Not ADA compliant. Reconfiguration will be required.
4 Windowe

Cabinets in second floor kitchen appear to be original and are not ADA accessible.

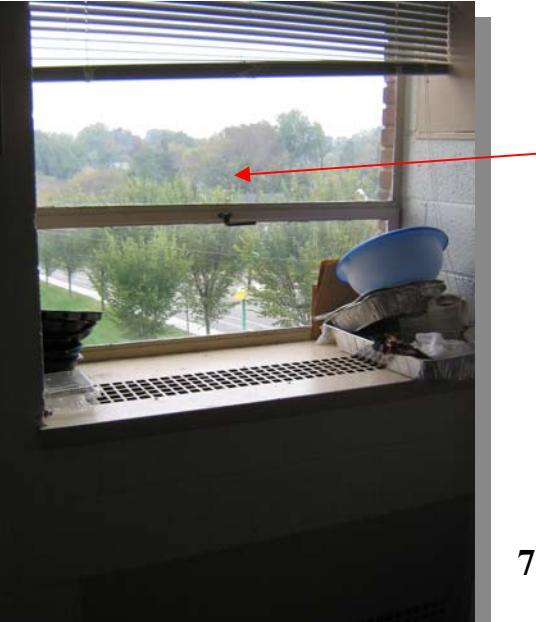
a. Existing aluminum awning windows	69	ea	\$650	\$	44,850	\$	44,850	0%	Failed	0.00	7	All windows are original, single pane, non- insulated aluminum awning windows and need to be replaced completely.

Original non-insulated single pane aluminum awning windows do not meet current energy code requirements

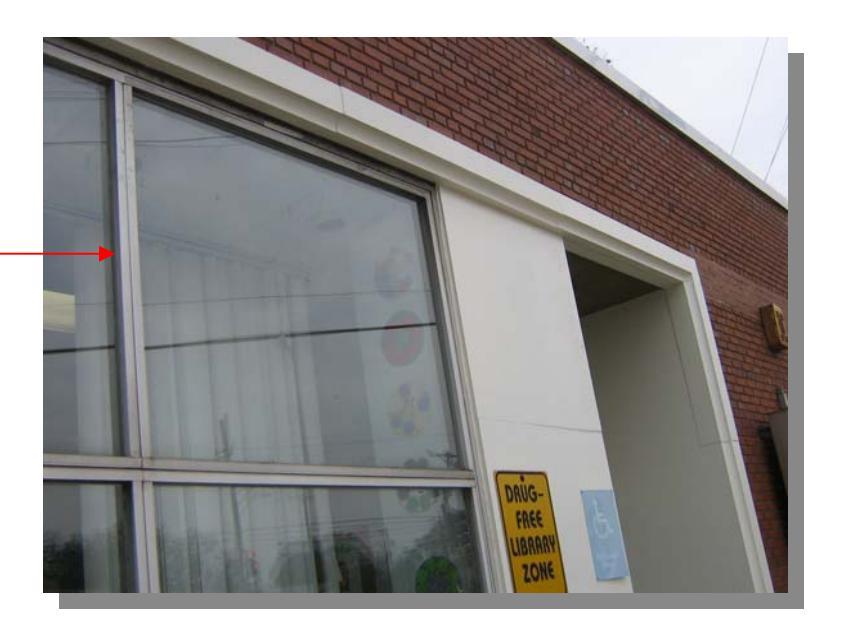
b. Existing aluminum storefront entry system	1	ls	\$8,500	\$	8,500	\$	8,500	0%	Failed	0.00	8	All aluminum are original, single pane, non- insulated aluminum storefront system and need to be replaced completely.

Original non-insulated aluminum storefront system does not meet current energy code requirements

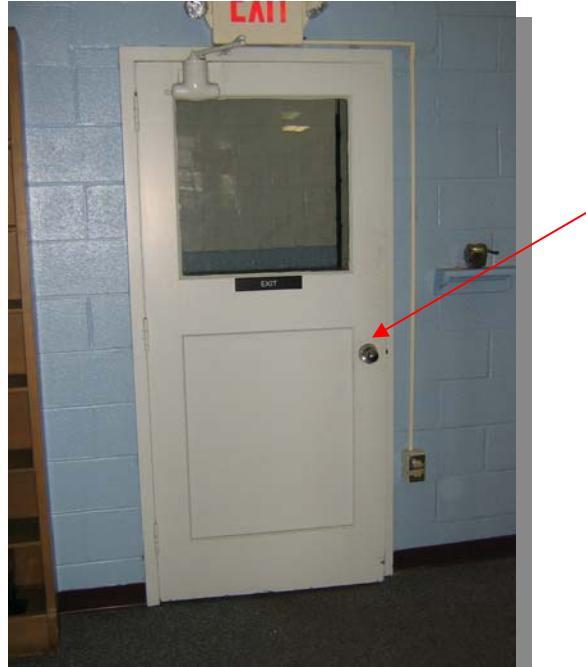
-										$\vdash$	
5 Deere	<u> </u>		<u>                                     </u>	-							<u> </u>	
<ol> <li>Doors         <ul> <li>Existing solid wood doors and frames and hardware</li> </ul> </li> </ol>	34	ea	\$850	\$	28,900	\$	28,900	0%	Failed	0.00	9	Existing solid wood doors and frames need to be replaced. Many of the fire doors do not latch properly due to sagging hinges and multiple layers of paint. Existing hardware is not ADA compliant.
	<u> </u>											
<ul> <li>a. Existing restrooms</li> </ul>	5	ea	\$20,000	\$	100,000	\$	40,000	60%	Fair	6.00	10	Two out of 4 public restrooms (5th bathroom is for janitor's use) do not meet ADA clearance requirements and need to be replaced completely. However, additonal restrooms would benefit the program needs of the space although they are not required by code. Staff has requested separate childrens bathrooms on the first floor.

Original solid wood door are worn as a result of years of use and many do not latch properly. The existing hardware is not ADA compliant

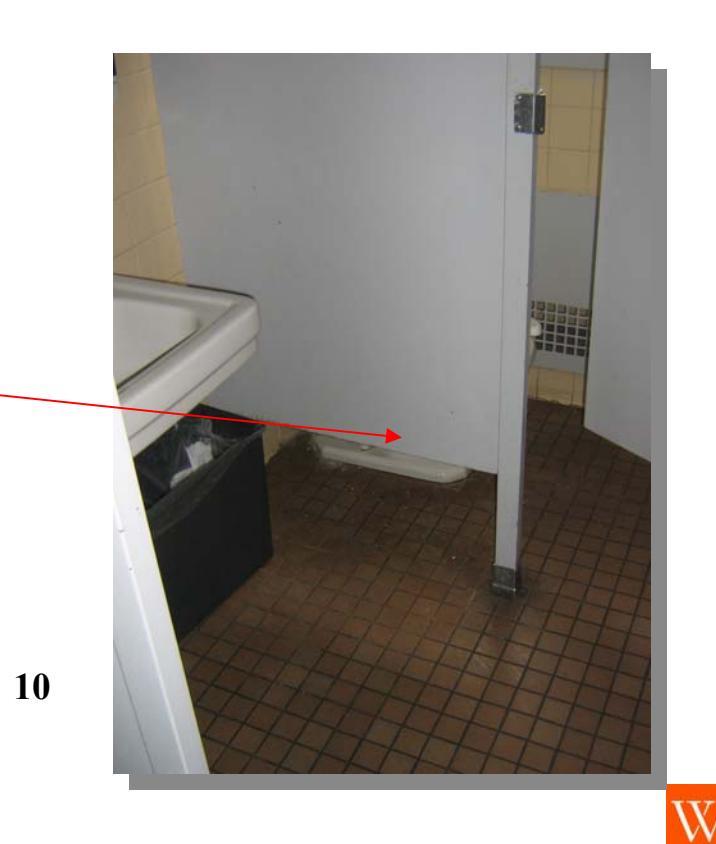
Existing second floor bathrooms are not ADA compliant. Currently there are not enough bathrooms in the building to satisfy code requirements or building programming requirements.

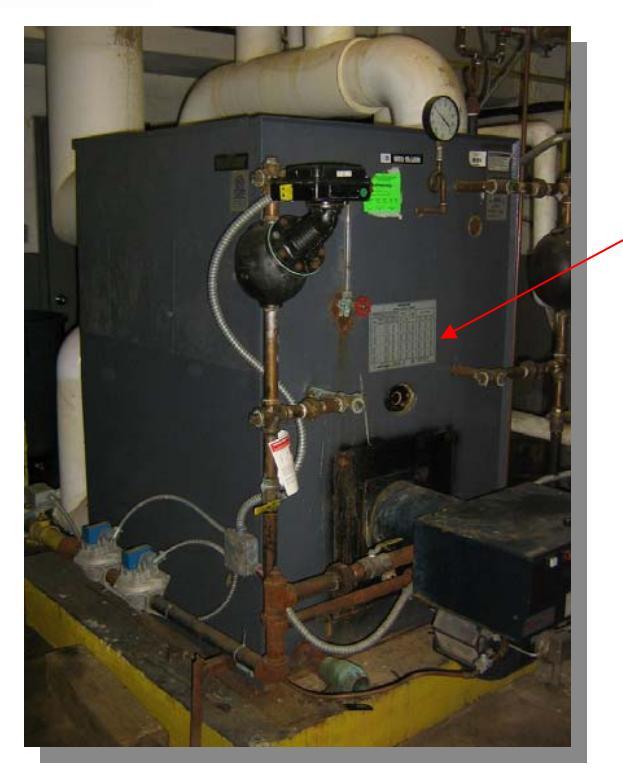
Five zone air handling unit in poor condition. Most dampers have failed and parts are not easily available. When unit operates, fan noise can be heard throughout reading and stack areas. Gas fired steam boiler less than 5 years old and in fair/good condition, not in compliance with LEED. Steam heating systems are obsolete and should be replaced with state of the art gas fired 90+ energy efficient hot water boiler system.

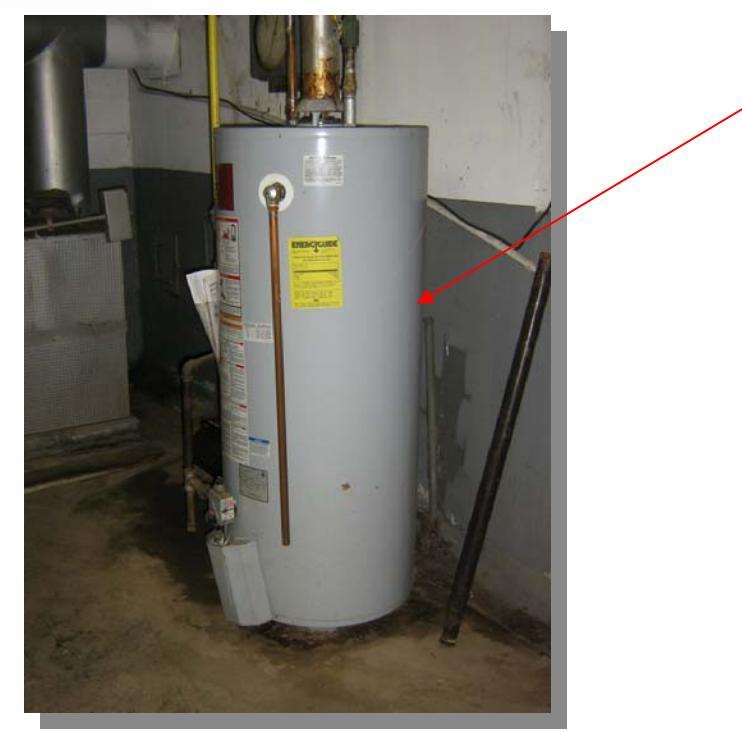
Gas fired domestic hot water heater is in fair/good condition however it is suggested that a more efficient 90+ tank-less water heater.

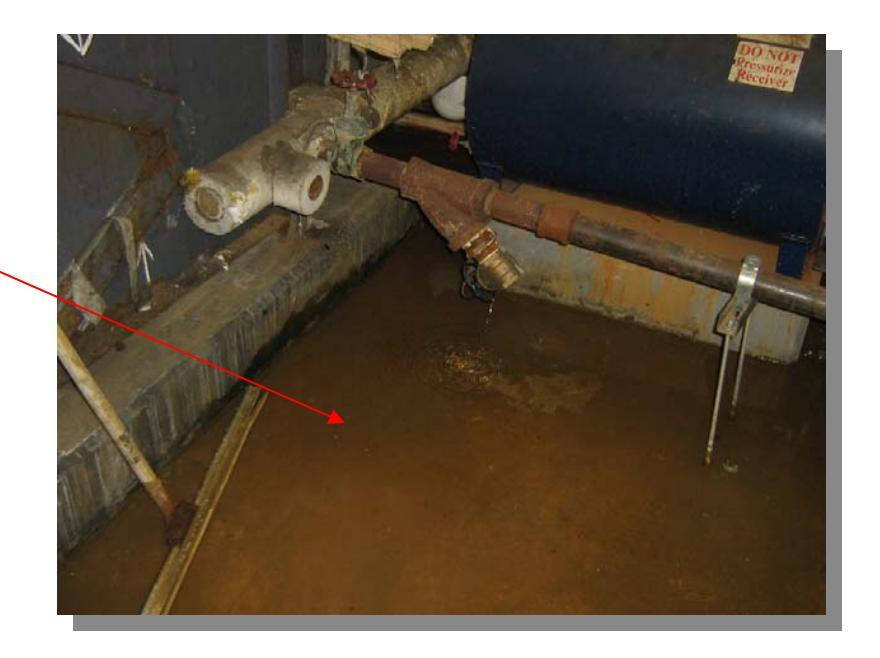
Steam condensate pump is leaking water adding to a higher makeup water cost. Additional floor drains in boiler room are required to drain water.

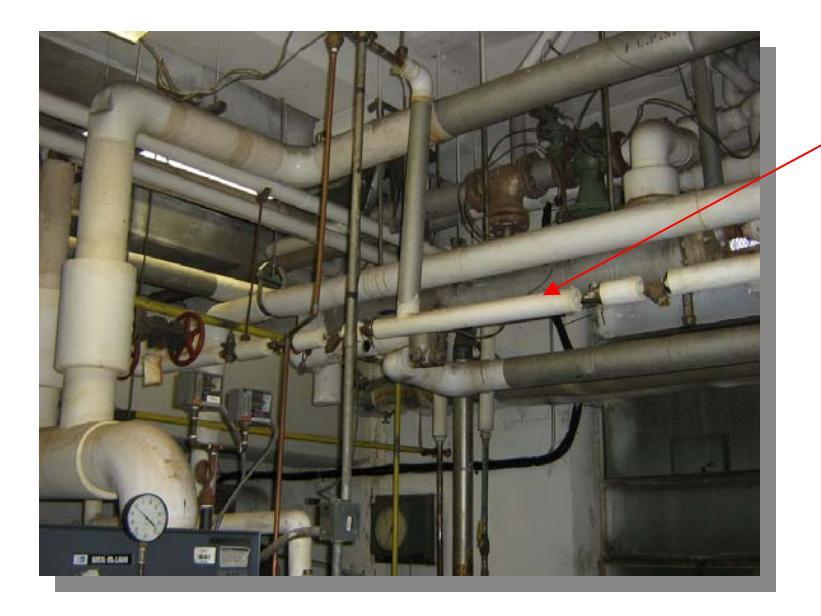
Heating and chilled water piping insulation in good condition.

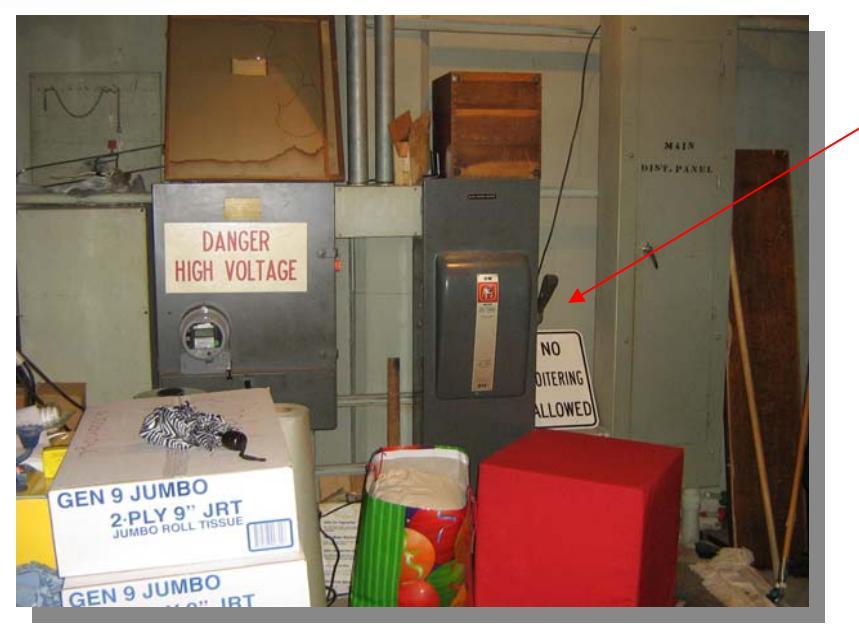
Electrical distribution equipment has outlived its useful life. Replacement parts are not readily accessible.

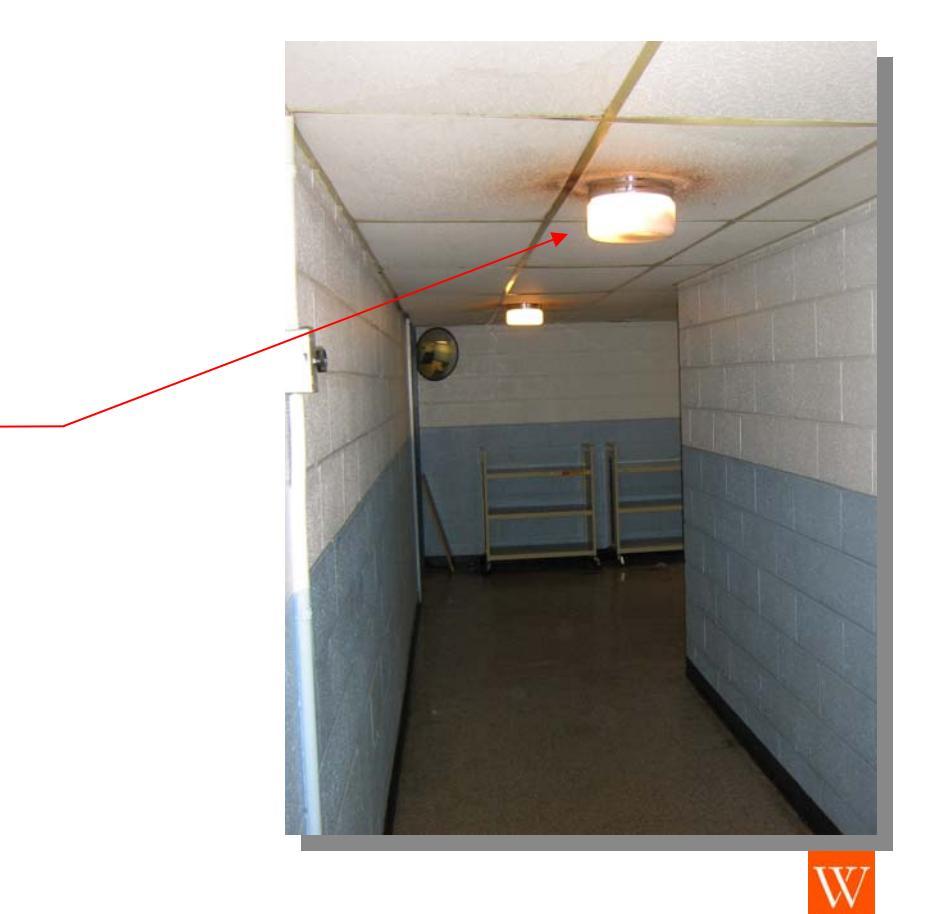
A majority of existing light fixtures are inefficient and not energy star compliant. Lighting levels in most areas are inadequate.

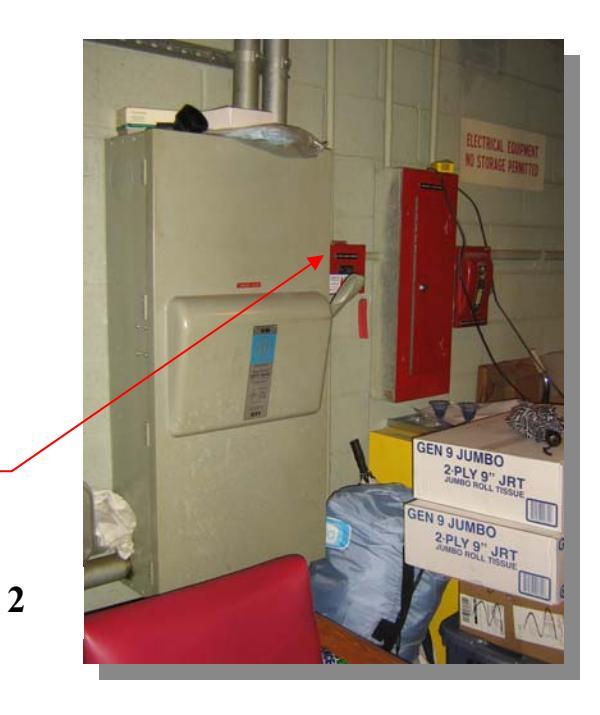
Original emergency lighting system must be replaced to meet current codes system.
