# Woodridge Library

1801 Rhode Island Avenue. NE, Washington, DC

## **Facility Condition Assessment & Cost Benefit Analysis**

January 10, 2011

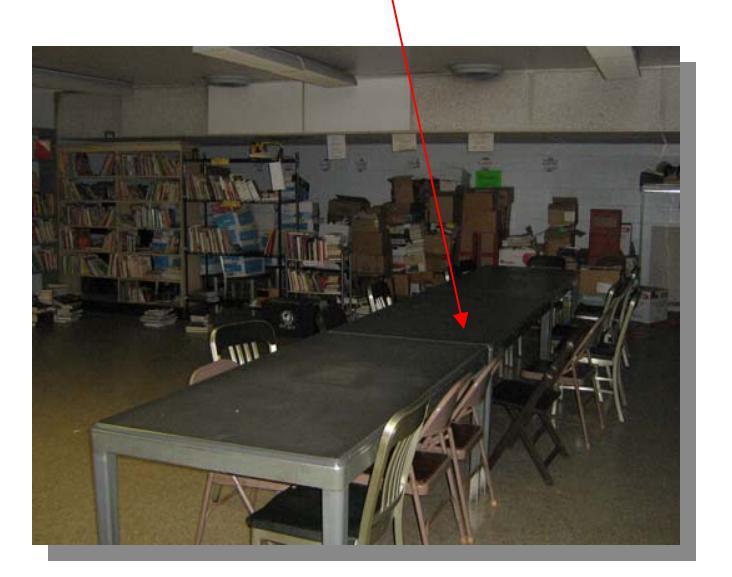
Floor and ceiling finishes, furniture and fixtures are dated and worn in meeting rooms and corridors in basement and second floor.

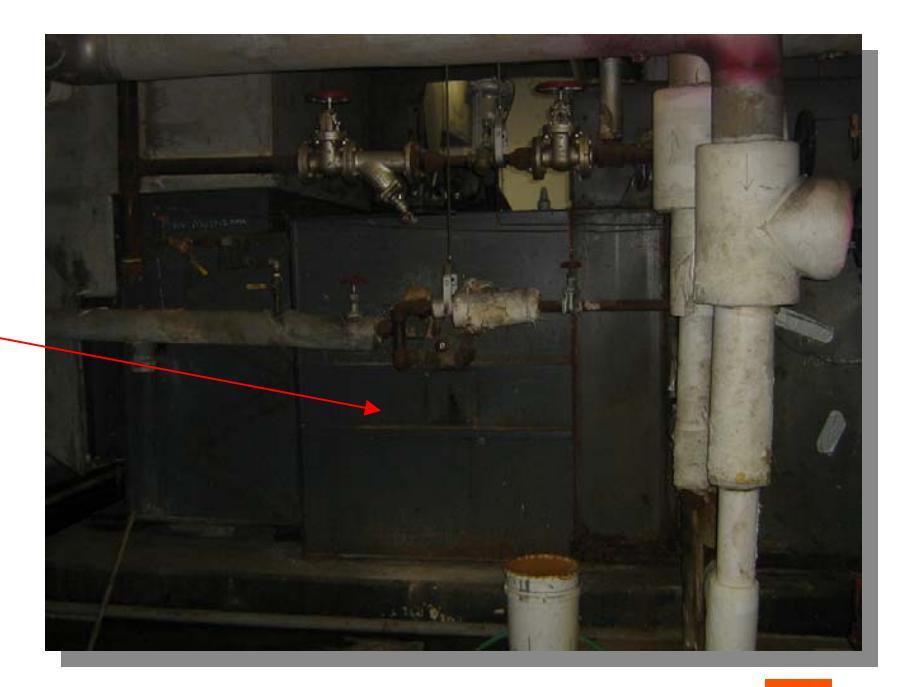
Five zone air handling unit in poor condition. Most dampers have failed and parts are not easily available. When unit operates, fan noise can be heard throughout reading and stack areas. Gas fired steam boiler less than 5 years old and in fair/good condition, not in compliance with LEED. Steam heating systems are obsolete and should be replaced with state of the art gas fired 90+ energy efficient hot water boiler system.
